# A Review of Australian and New Zealand Investigations on Aeronautical Fatigue During the Period April 2009 to March 2011

**Air Vehicles Division**  
Defence Science and Technology Organisation

DSTO-TN-0993

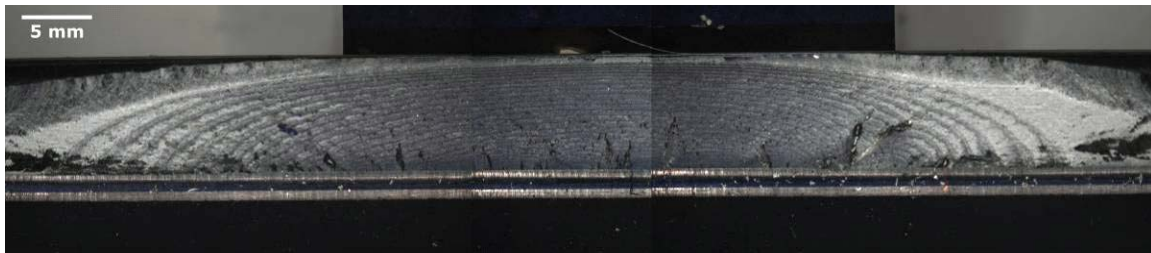
Figure 4: Typical fracture surface for coupons with optimised profile

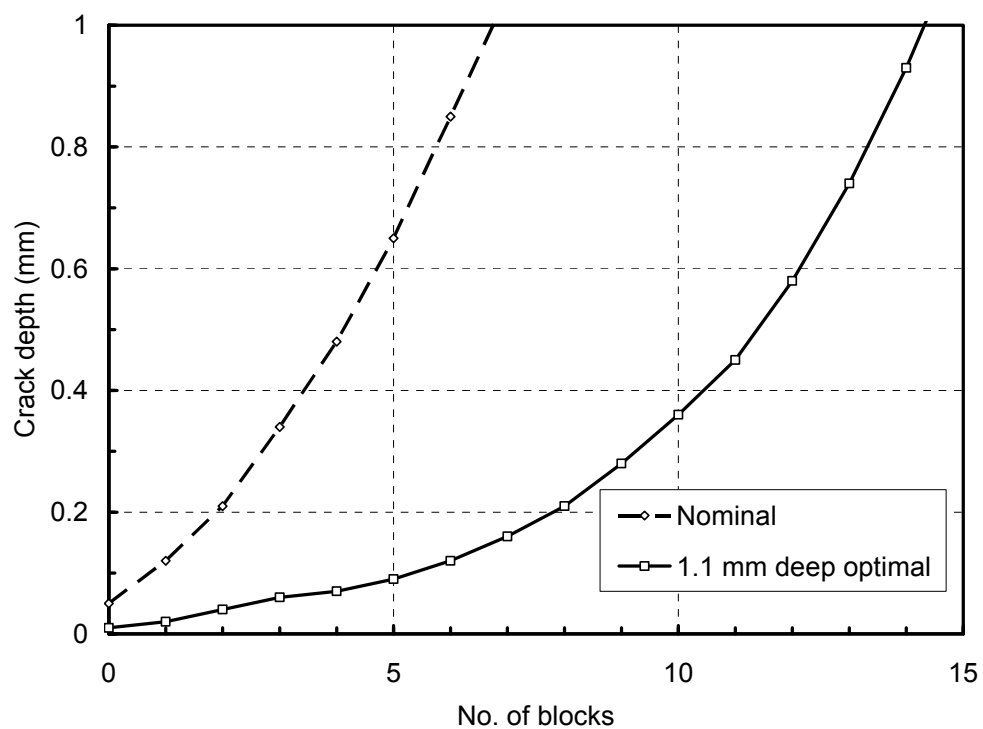
Figure 5: Average fatigue crack depth (over five tests) for coupons with nominal and 1.1 mm deep optimal profiles as a function of loading block number

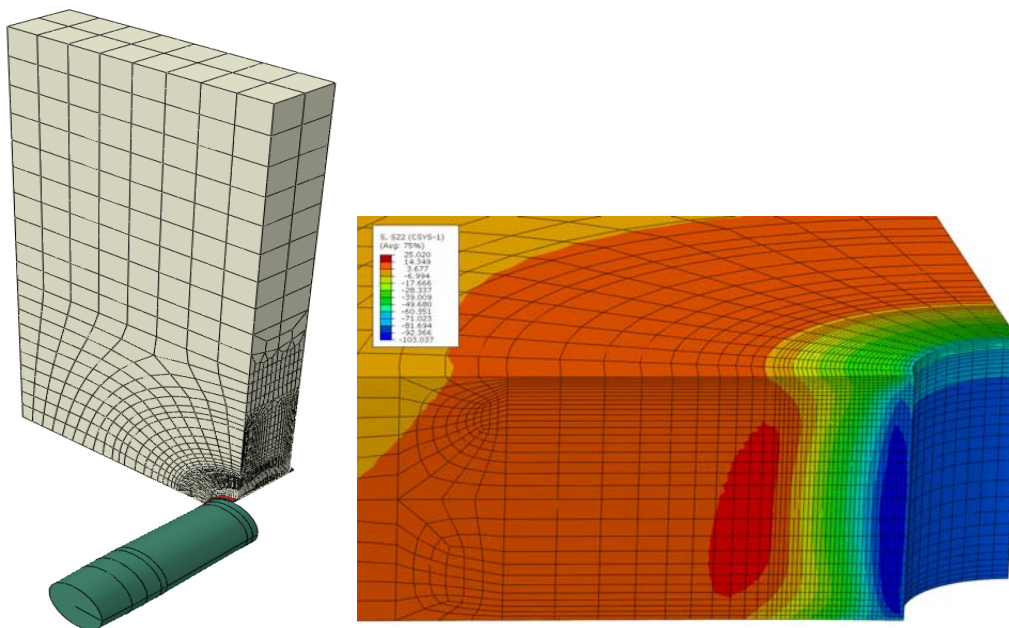
Figure 1: Finite Element model (left) and residual stress profile for the cold expansion process

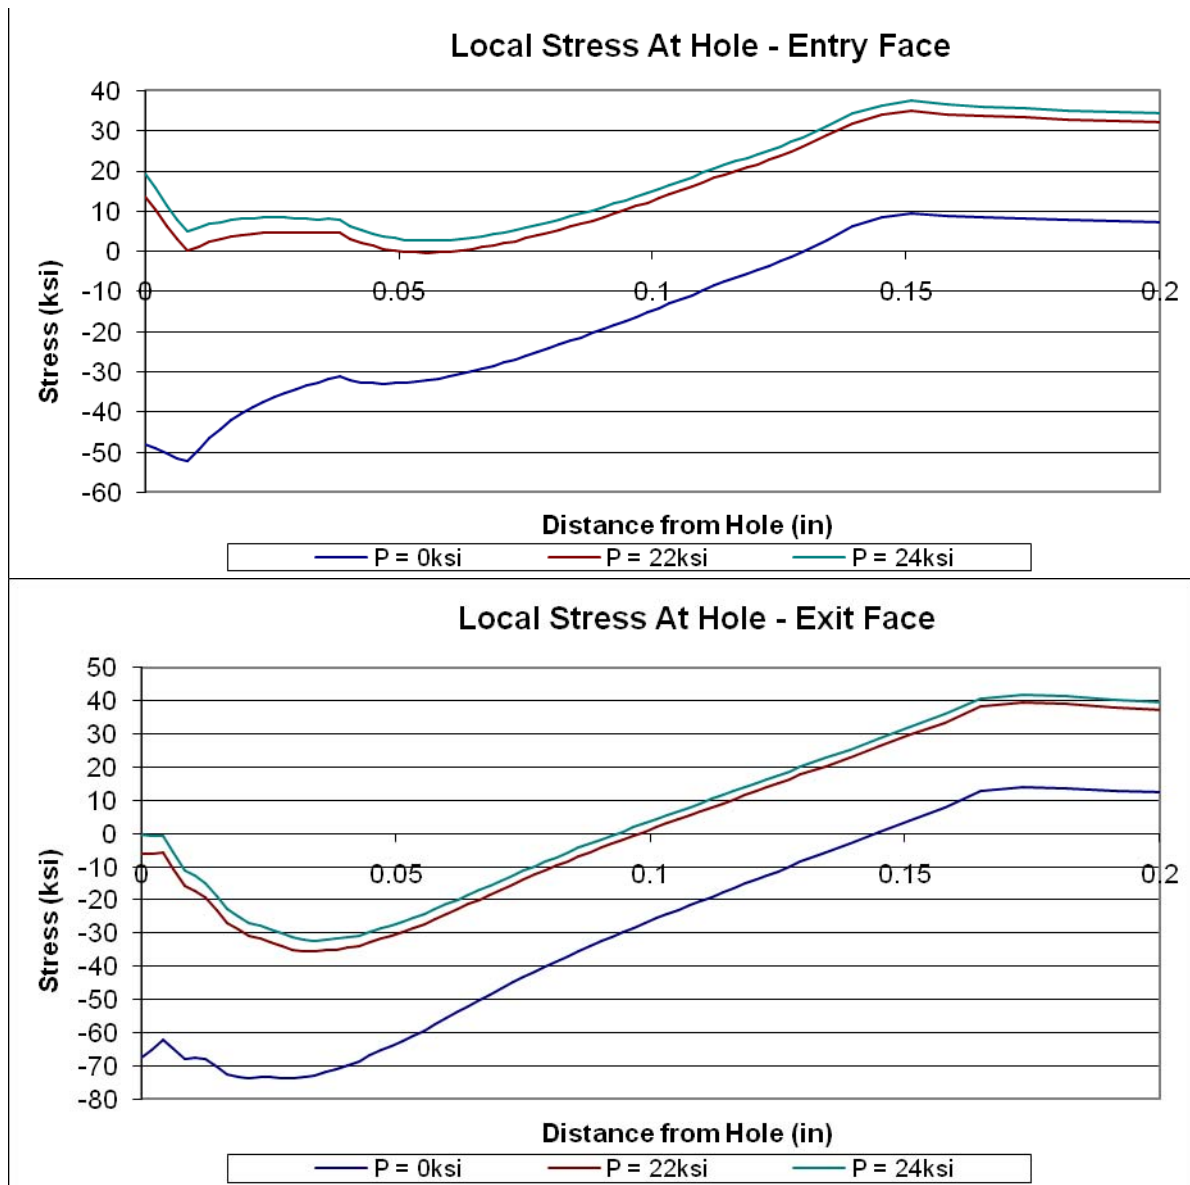
Figure 2: Tangential residual stress profiles for measured at the mandrel entry face (upper) and mandrel exit face (lower) for each of three different levels of remote tensile load.

A constant amplitude fatigue testing programme was conducted to ascertain the correlation of predicted residual stress fields and the fatigue properties of cold expanded fastener holes. For constant amplitude fatigue loading below the tensile threshold, small fatigue cracks initiated and then arrested, with no crack growth after 10 Million fatigue cycles. There was good correlation between the size and shape of these cracks and the residual stress field predicted by the FE simulation.

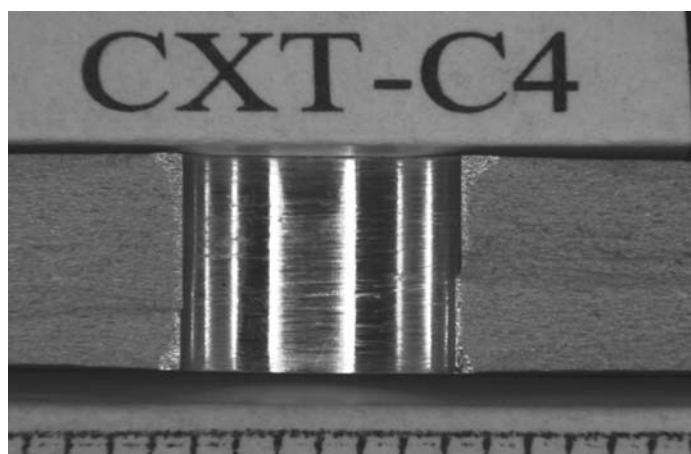
Figure 3: Fracture surface for a non-propagating fatigue crack (after 40 million cycles with a peak stress of 18 ksi at  $R=0.1$ ).

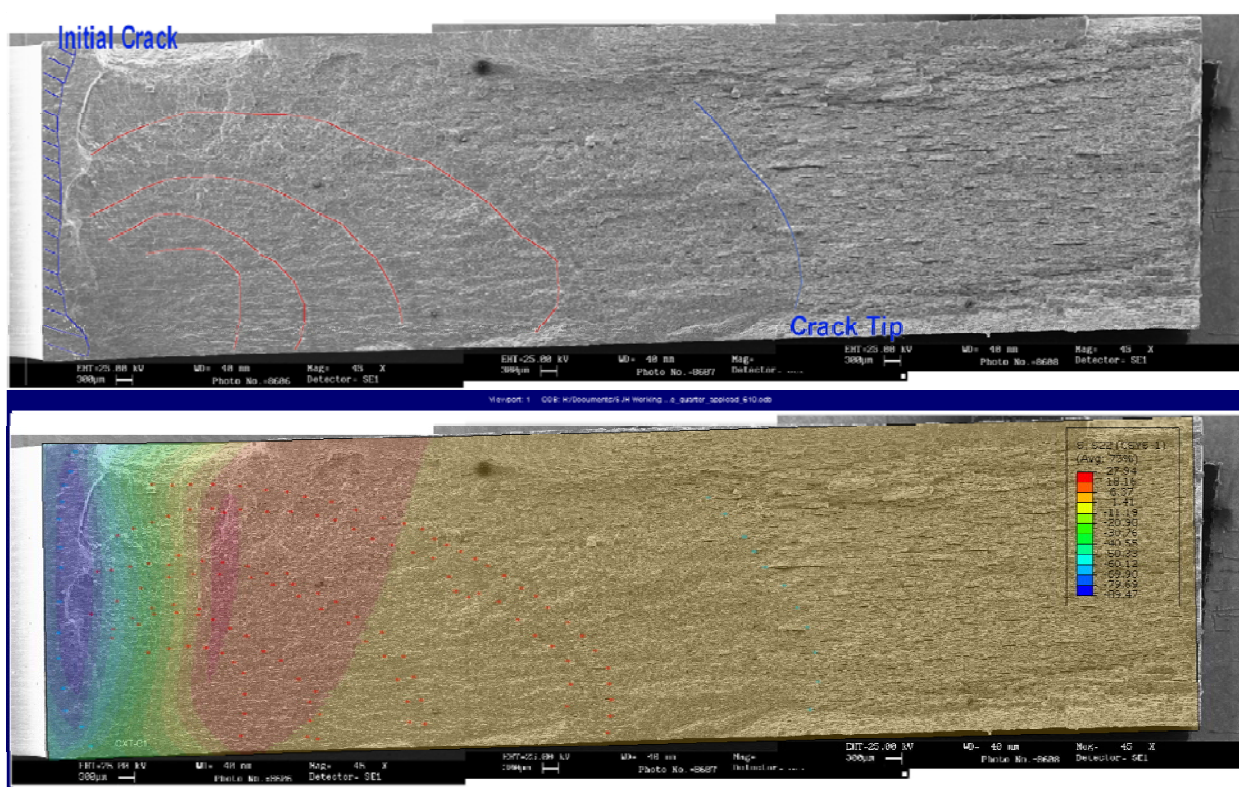
Figure 4: Fracture surface for a propagating fatigue crack (1.5 million cycles, peak stress 24 ksi at  $R=0.1$ ). Marker bands (coloured in the top image) show successive positions of the crack front. The lower image overlays the FE predicted tangential stresses for an applied load of 24 ksi

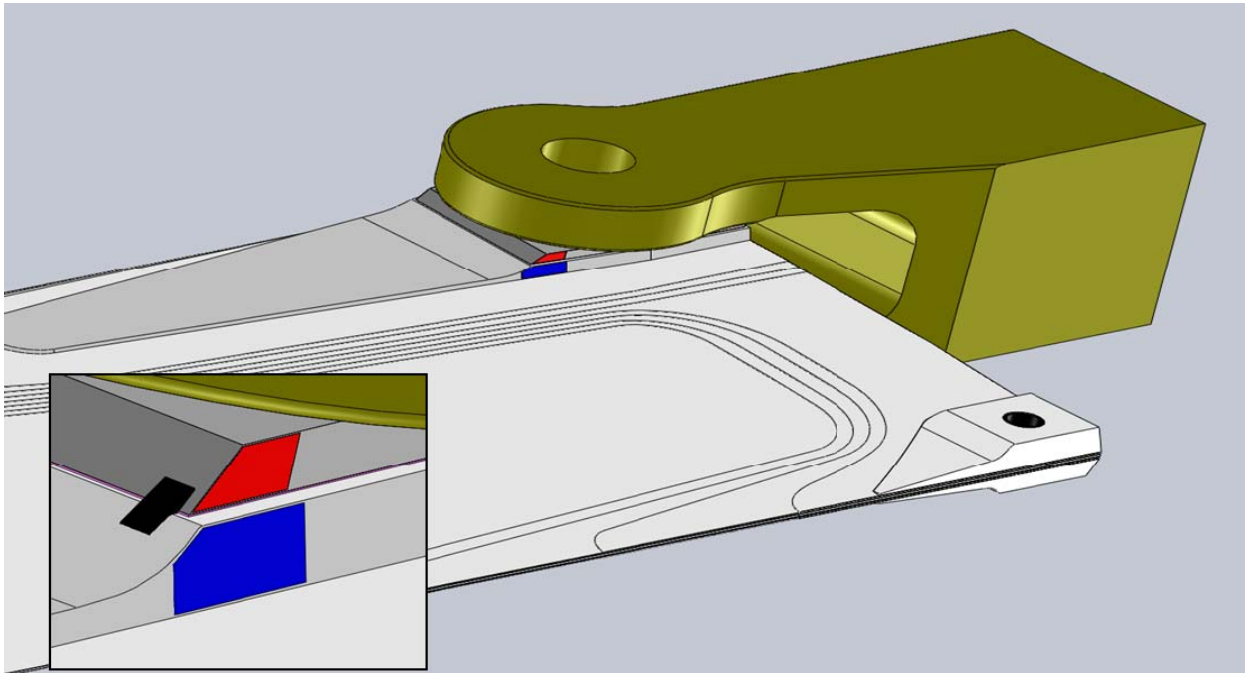
Figure 1: The underside of the UH-1H Rotor Blade and attachment clevis. The inset shows the Strain Gauge Technique gauge location (black) and the areas where a DIC speckle pattern was applied (Red and Blue)

DTA and the University of Auckland have undertaken a series of trials to determine the feasibility of using DIC to measure the relative movement of the bonded elements of rotor blade end fittings. A critical requirement for the test is to be able to determine the integrity of the critical adhesive bond without removing the blade.

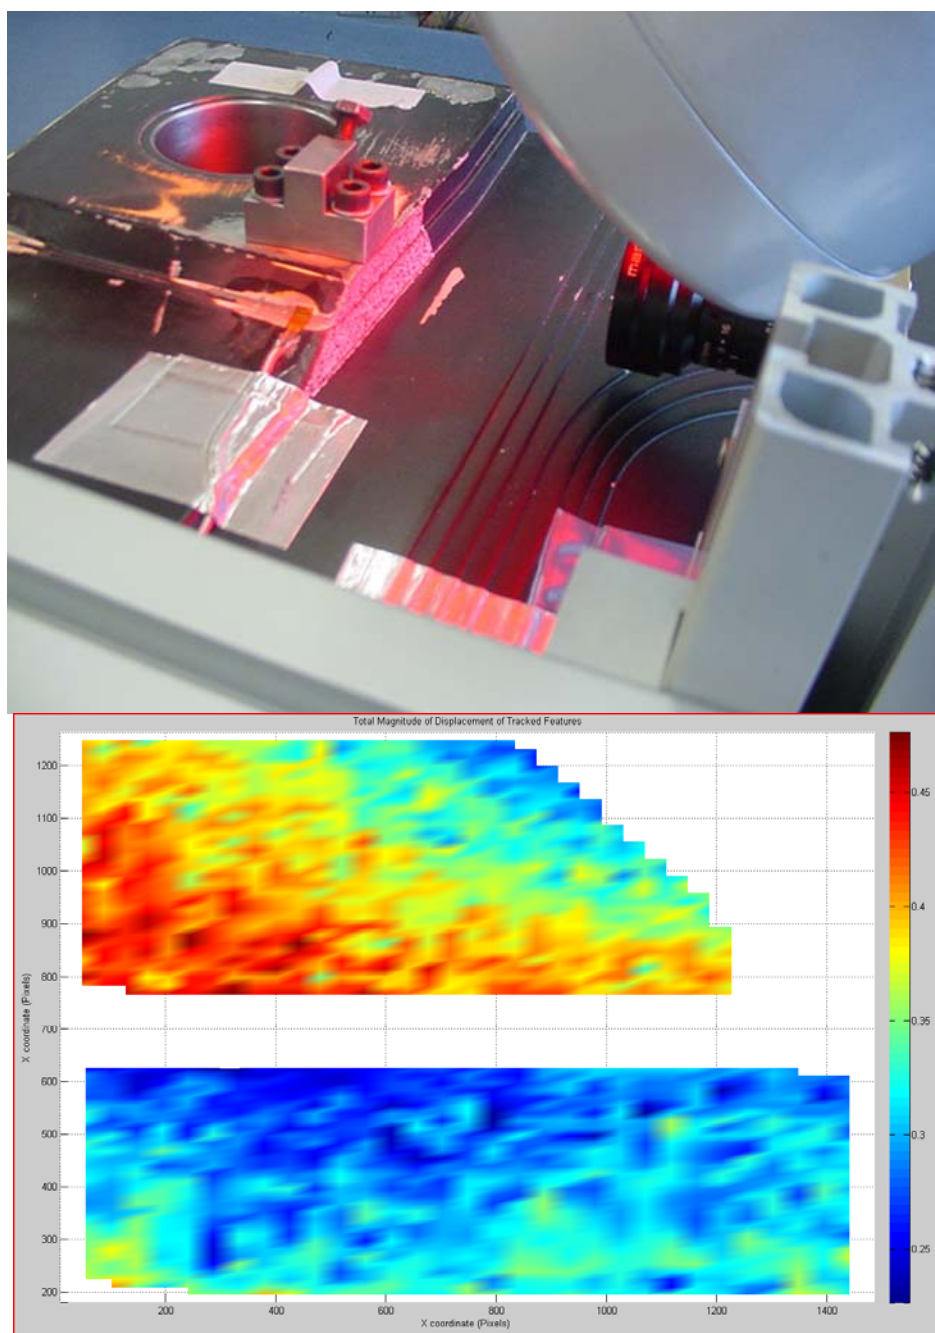
Figure 2: A preliminary trial of the DIC, using a low resolution camera and unrepresentative loading and no rotor attachment clevis (upper image) showed promise in measuring displacement fields (lower image).

Results to date have been obtained using a 5 megapixel camera at distances of 230mm, 400mm and 630mm, trialled on a sample of three blades. The technique shows promise. The trials have provided indications out of plane displacement, which affect the image tracking algorithm employed by DIC. Techniques to help resolve this by improving the image sharpness (using adjustments of lens focal length, lighting and exposure times) are underway.
